Case Study: A Process Slurry Pump

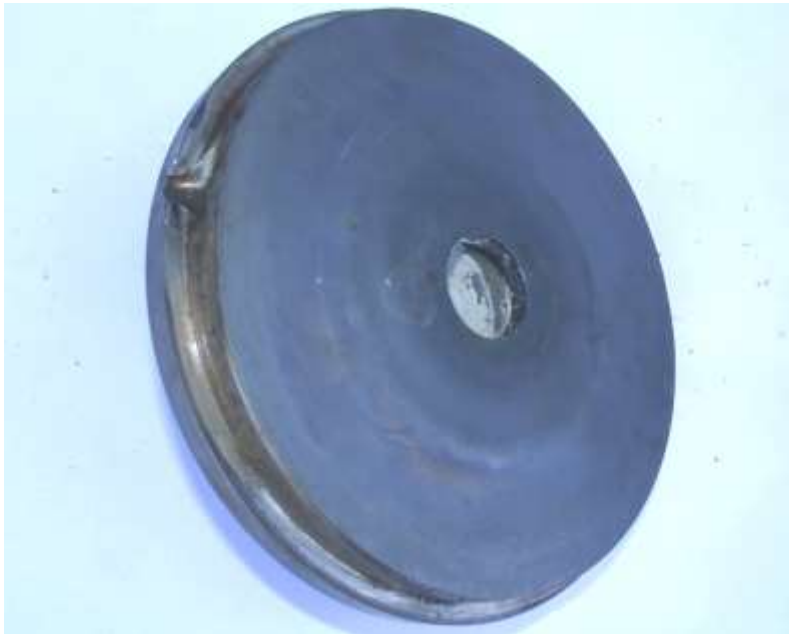
Results: Here is the backing plate with the as applied HVAF tungsten carbide coating after one year of service.

After measuring the coating thickness, we found that the thickness after one year of service was identical to the originally applied coating thickness.

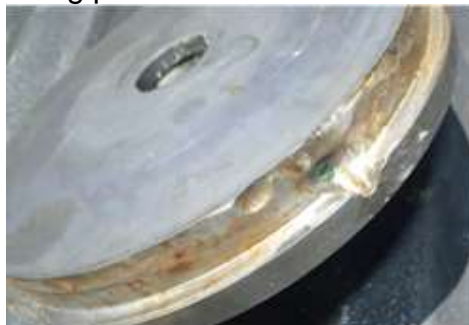
As we began to examine the backing plate we found an interesting area seen below.

The backing plate seal to the housing wasn't absolute, and some erodent made it past the coated surface of the backing plate and eroded material from under the coating. It is hard to see in the photo, but the coating is undercut and is still intact forming a sharp overhang of the coating. Here is a close up of the eroded area.

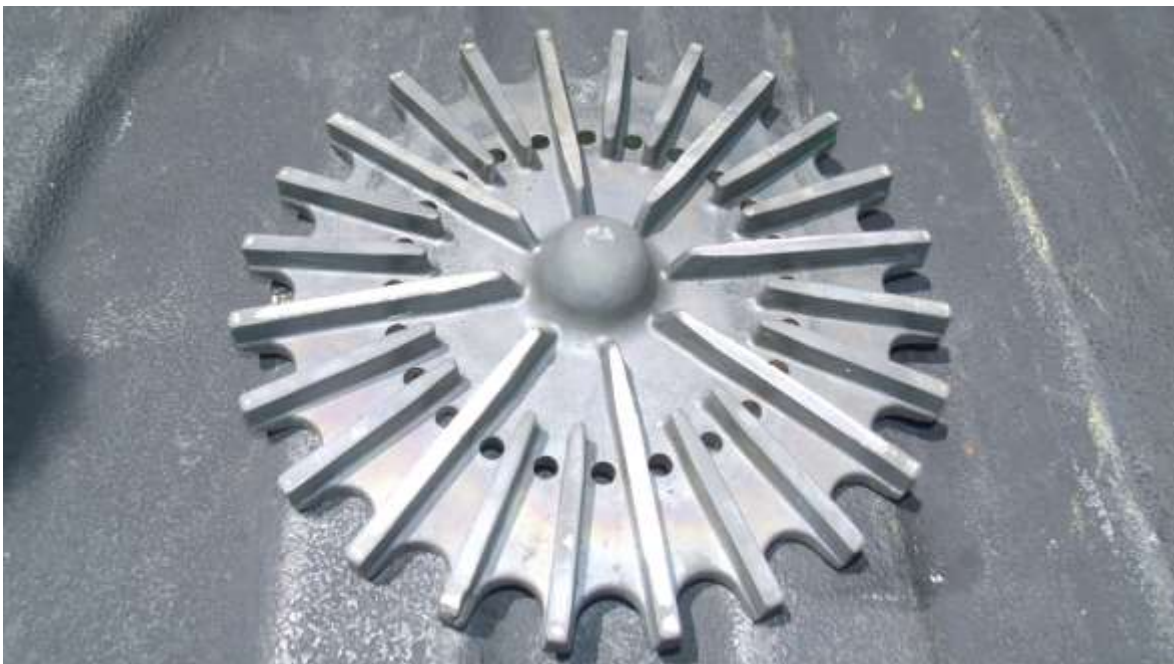
The other main parts of this slurry pump didn't fare as well. The impeller shown below lost much of the applied coating and the blades were wearing away fast. If the pump didn't begin leaking, the impeller would have failed after little additional service. Here is a look at the impeller.

The plan: Our customer has decided that the best course of action is to coat everything with Kermetico's HVOF 86-10Co-4Cr tungsten carbide coating. We wholeheartedly agree with his decision.

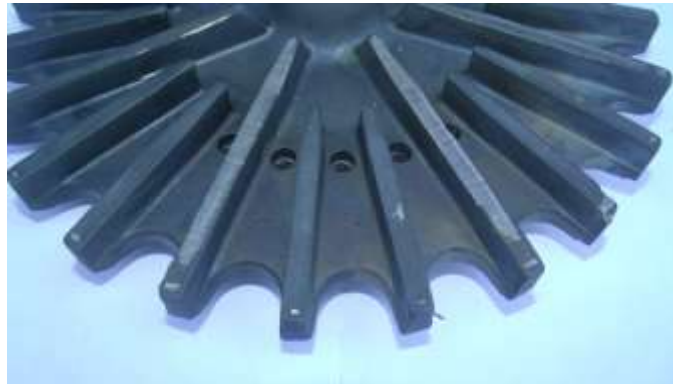
In the close-up view, you can see where the HVOF coating is completely gone.

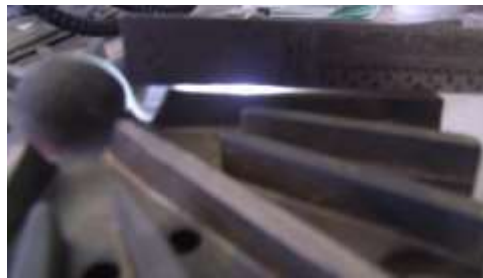
In those areas where the coating is worn away the metal is being worn away quickly as those blades are significantly shorter than the adjacent blades that still have coating remaining on the surface. This can be seen using a straight edge and a little back lighting.

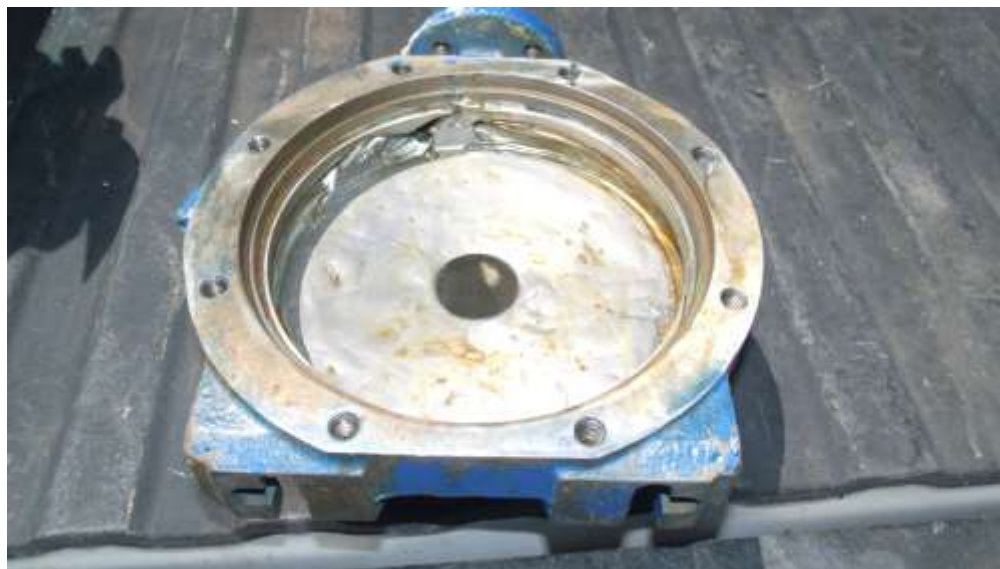
The pump case didn't do well either. Here is a look at it as received.

The damage is readily apparent.

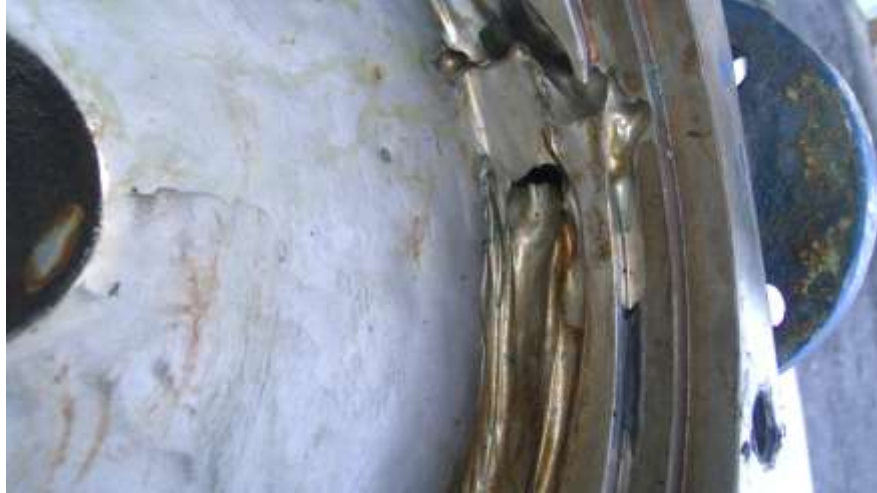
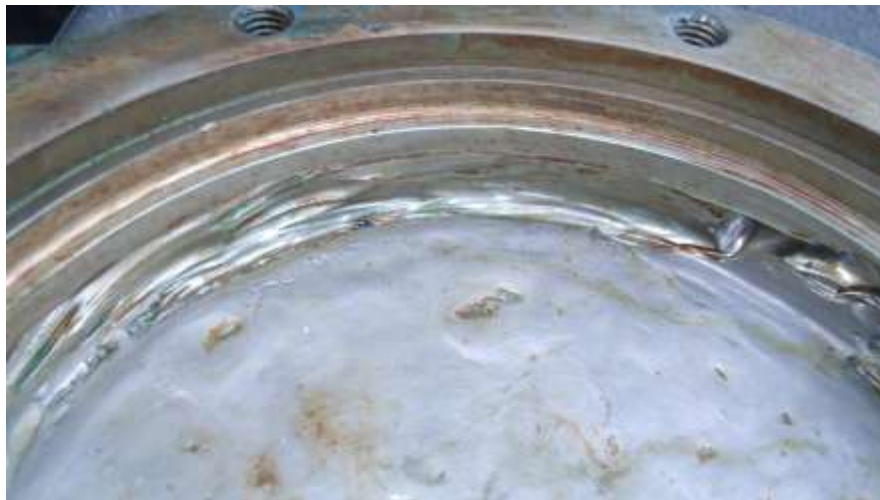
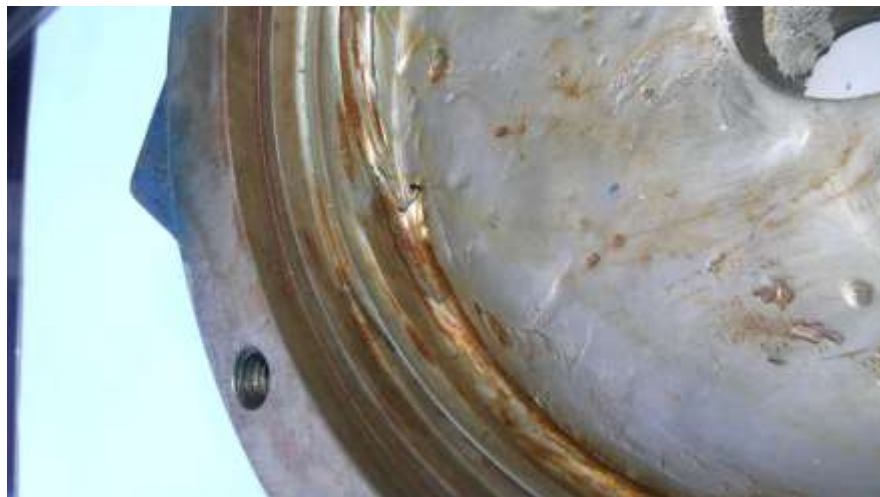
In these close-up views, the extent of this damage can be seen.
