Thermal spray coatings to protect refinery equipment from corrosion wear

A Quick Case Study

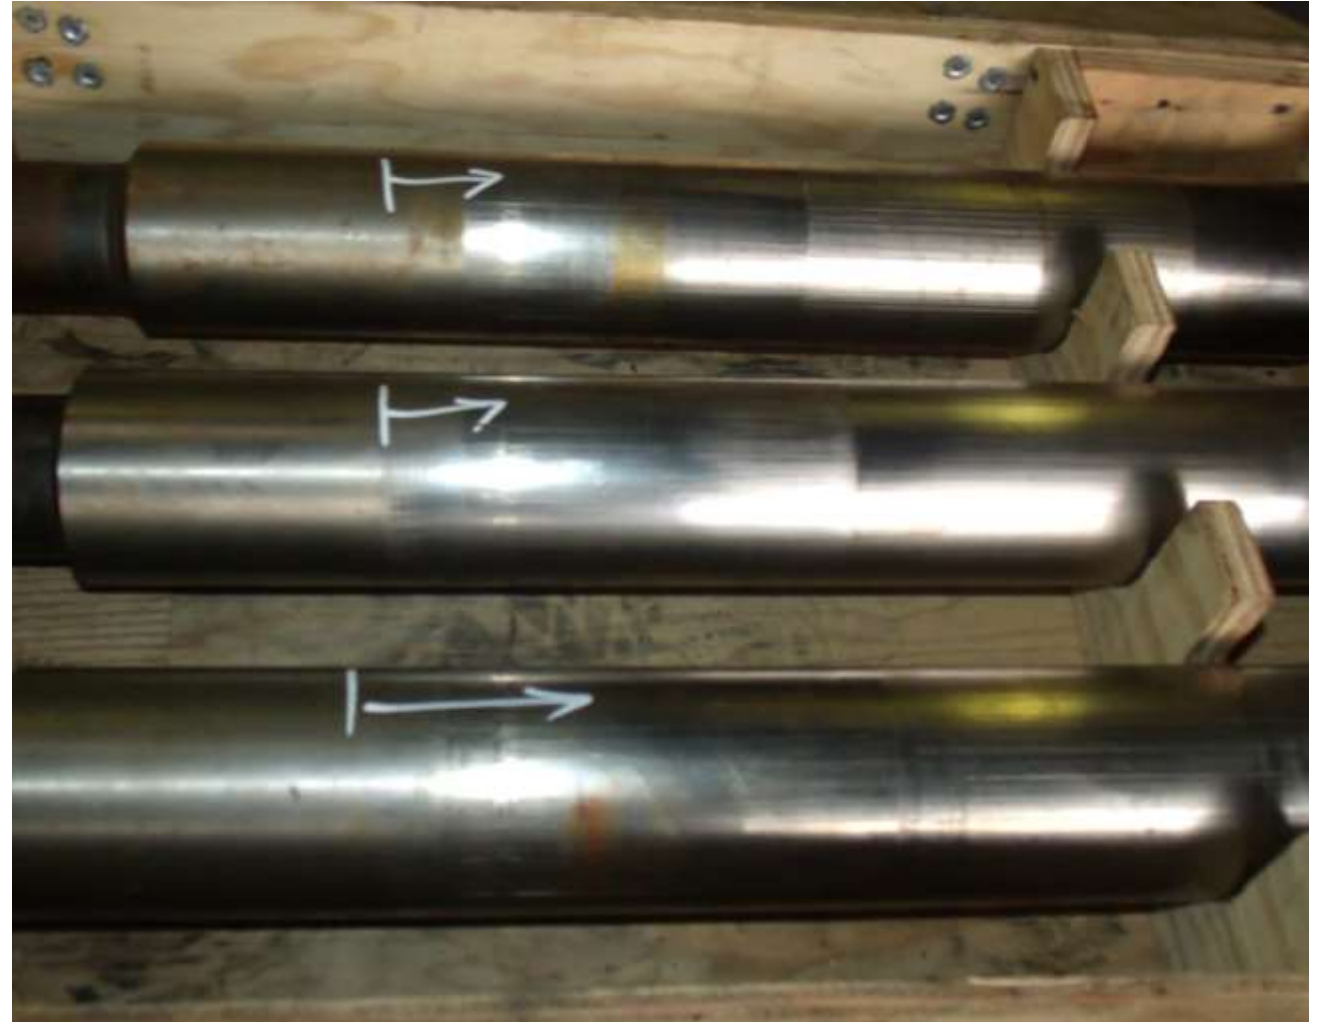
Fused coating damage after only one year

The damage was
caused by erosive
particles trapped
under the packing

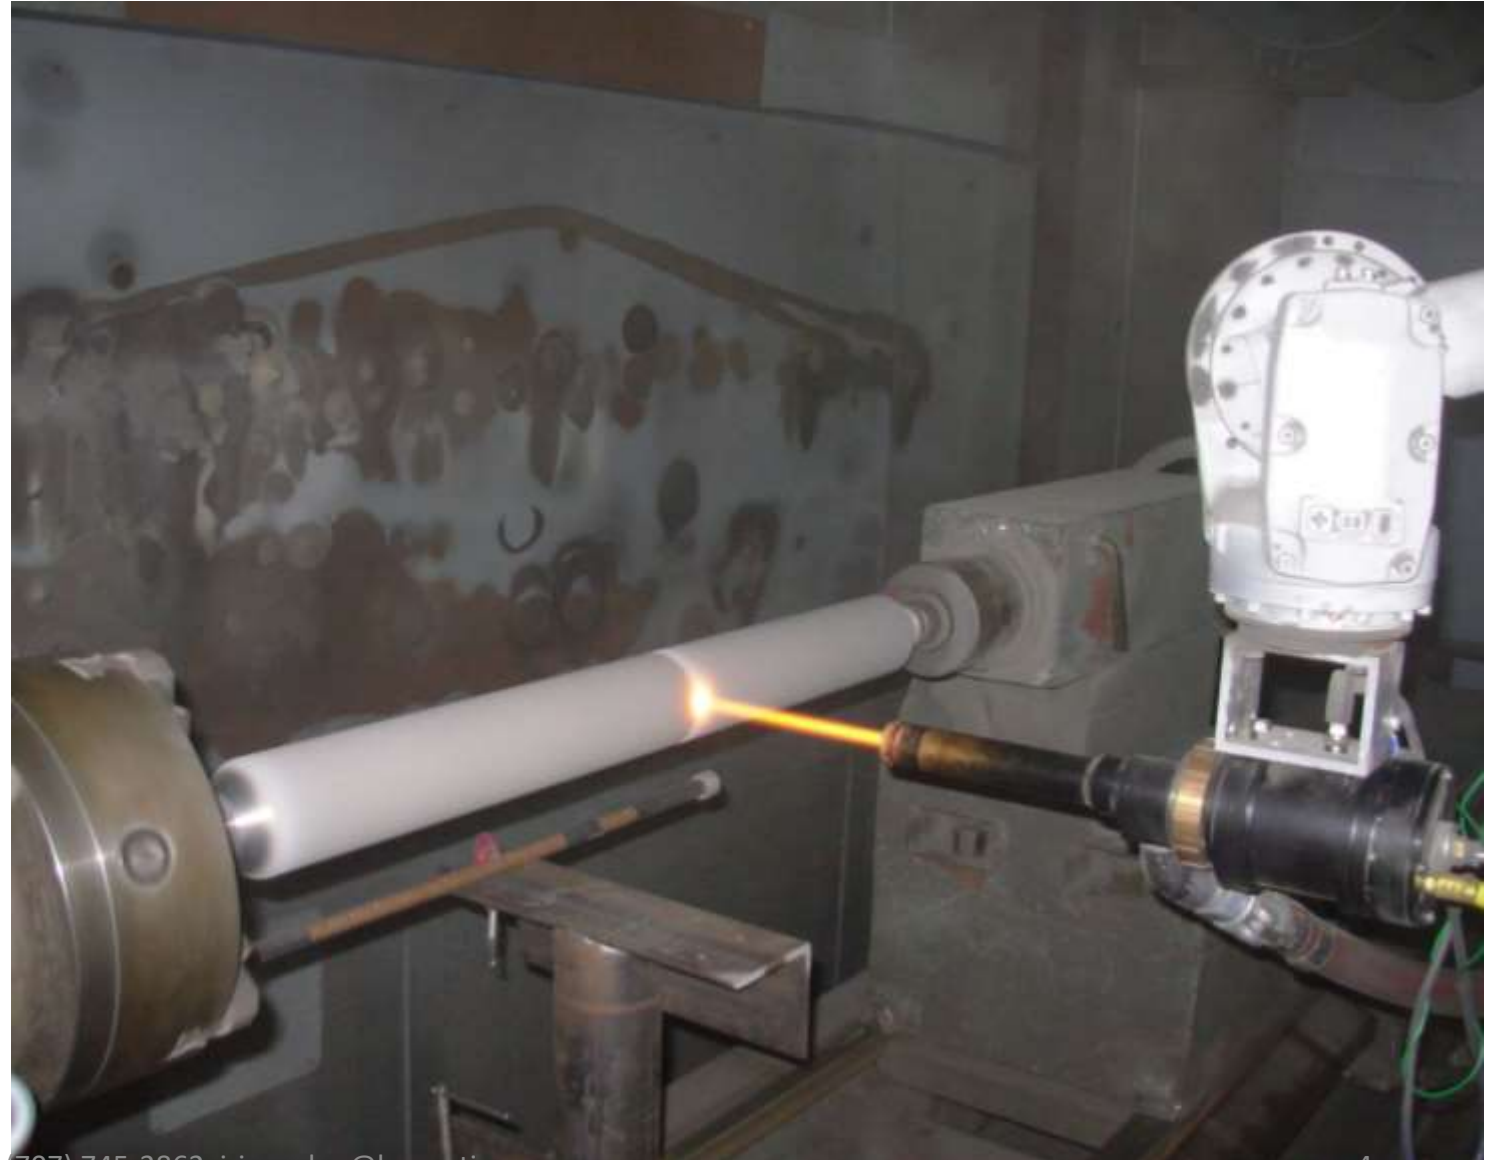
Here's one of the three being sprayed

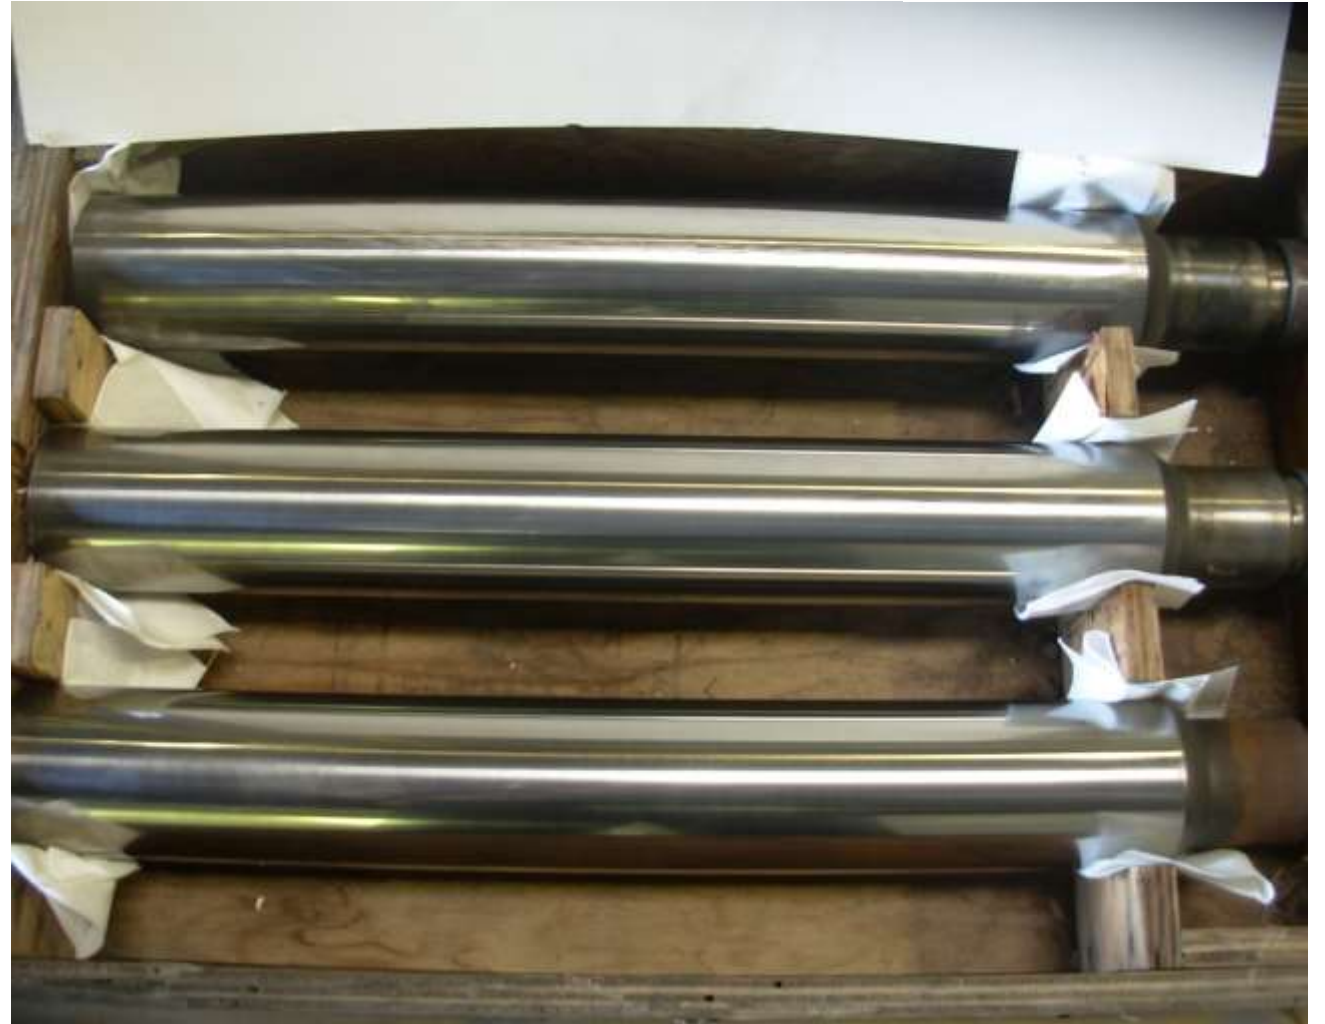
**Three Plungers ready
to go back into
service**

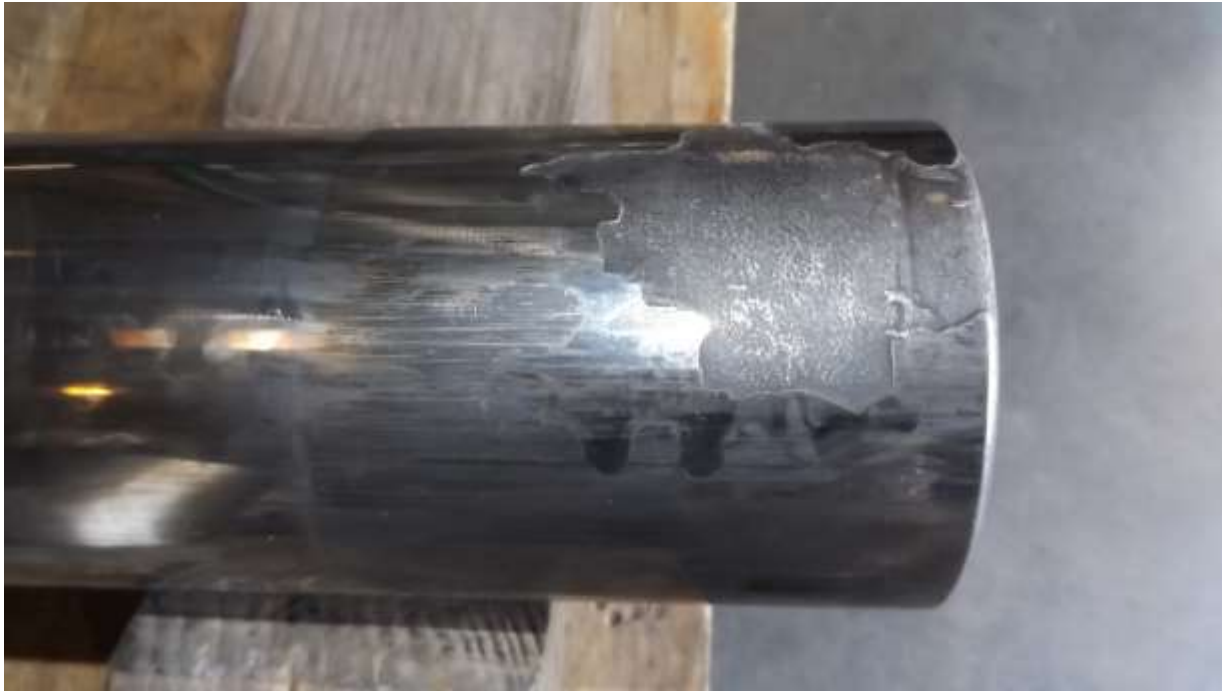
March 24, 2016 > 4.5 years later

So went wrong and why do we only have two? What happened to #3?

- Lubricant supply to plunger #1 was interrupted
- This caused severe overheating of the coating and the loss of coating integrity
- Some time later lubricant supply to #2 was interrupted, and the seal began leaking causing “water jetting” which eroded the coating. This is when they noticed the problem
- Plunger #3 never lost lubrication and is still in service
- The ruined plungers were exactly the same size as when they left our shop.

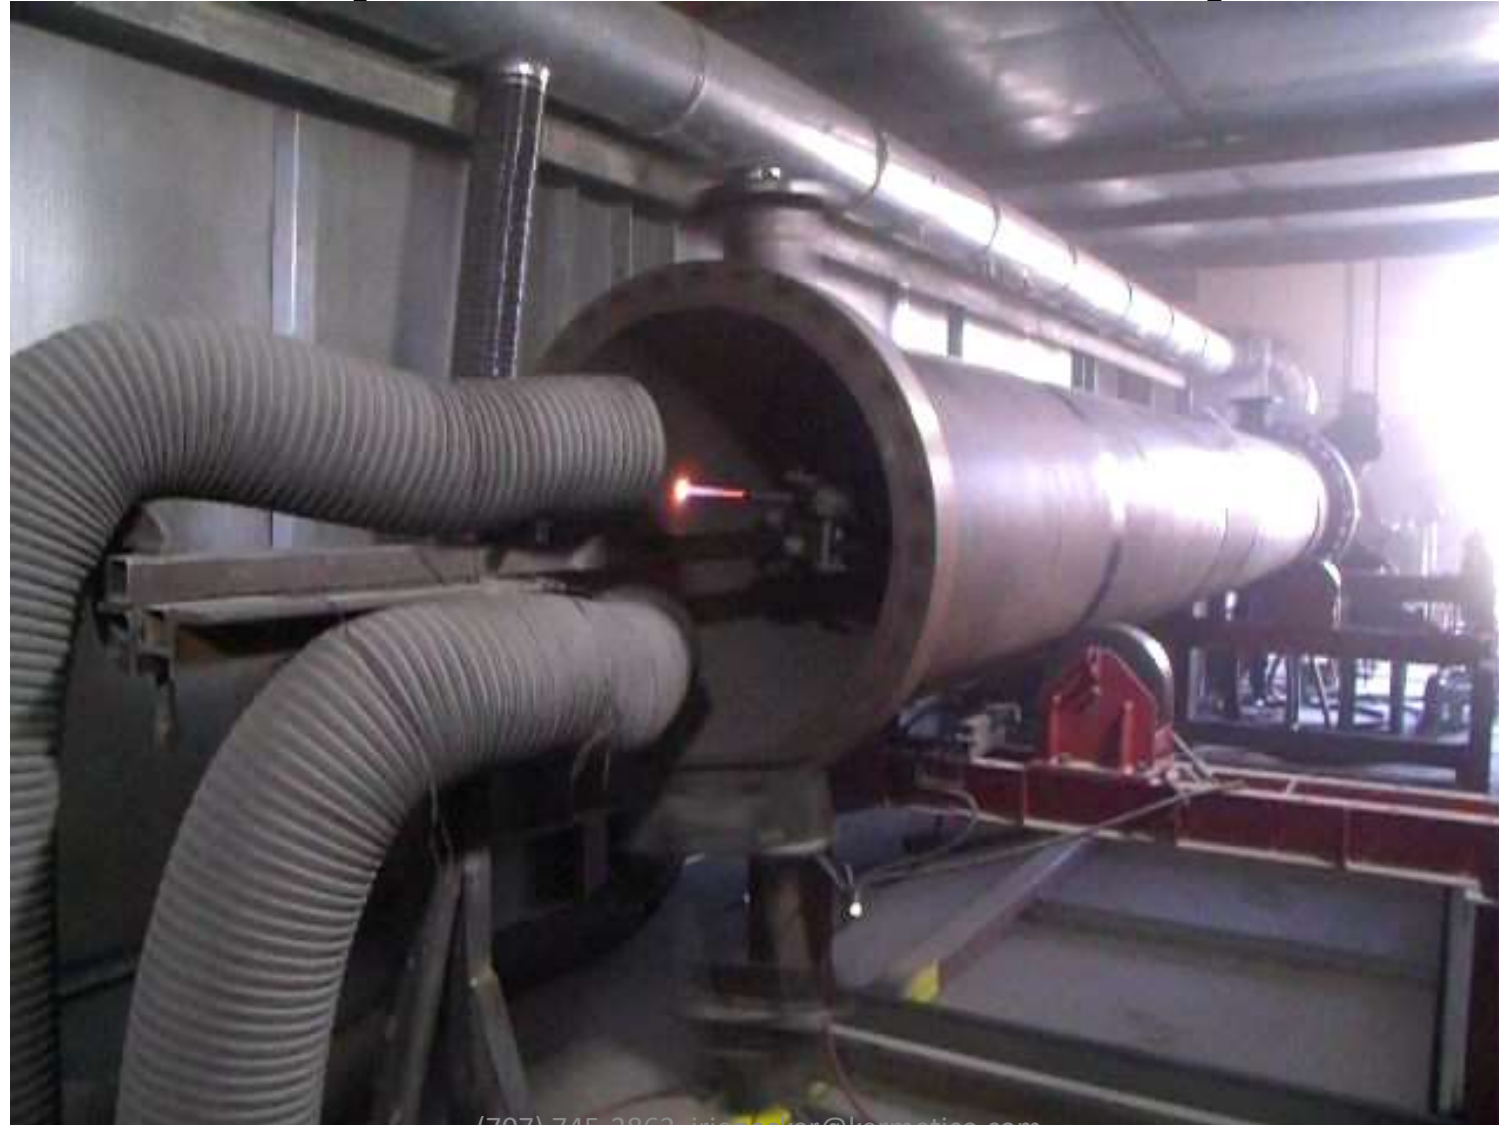
Piping and vessel erosion and wear protection Hastelloy "C"

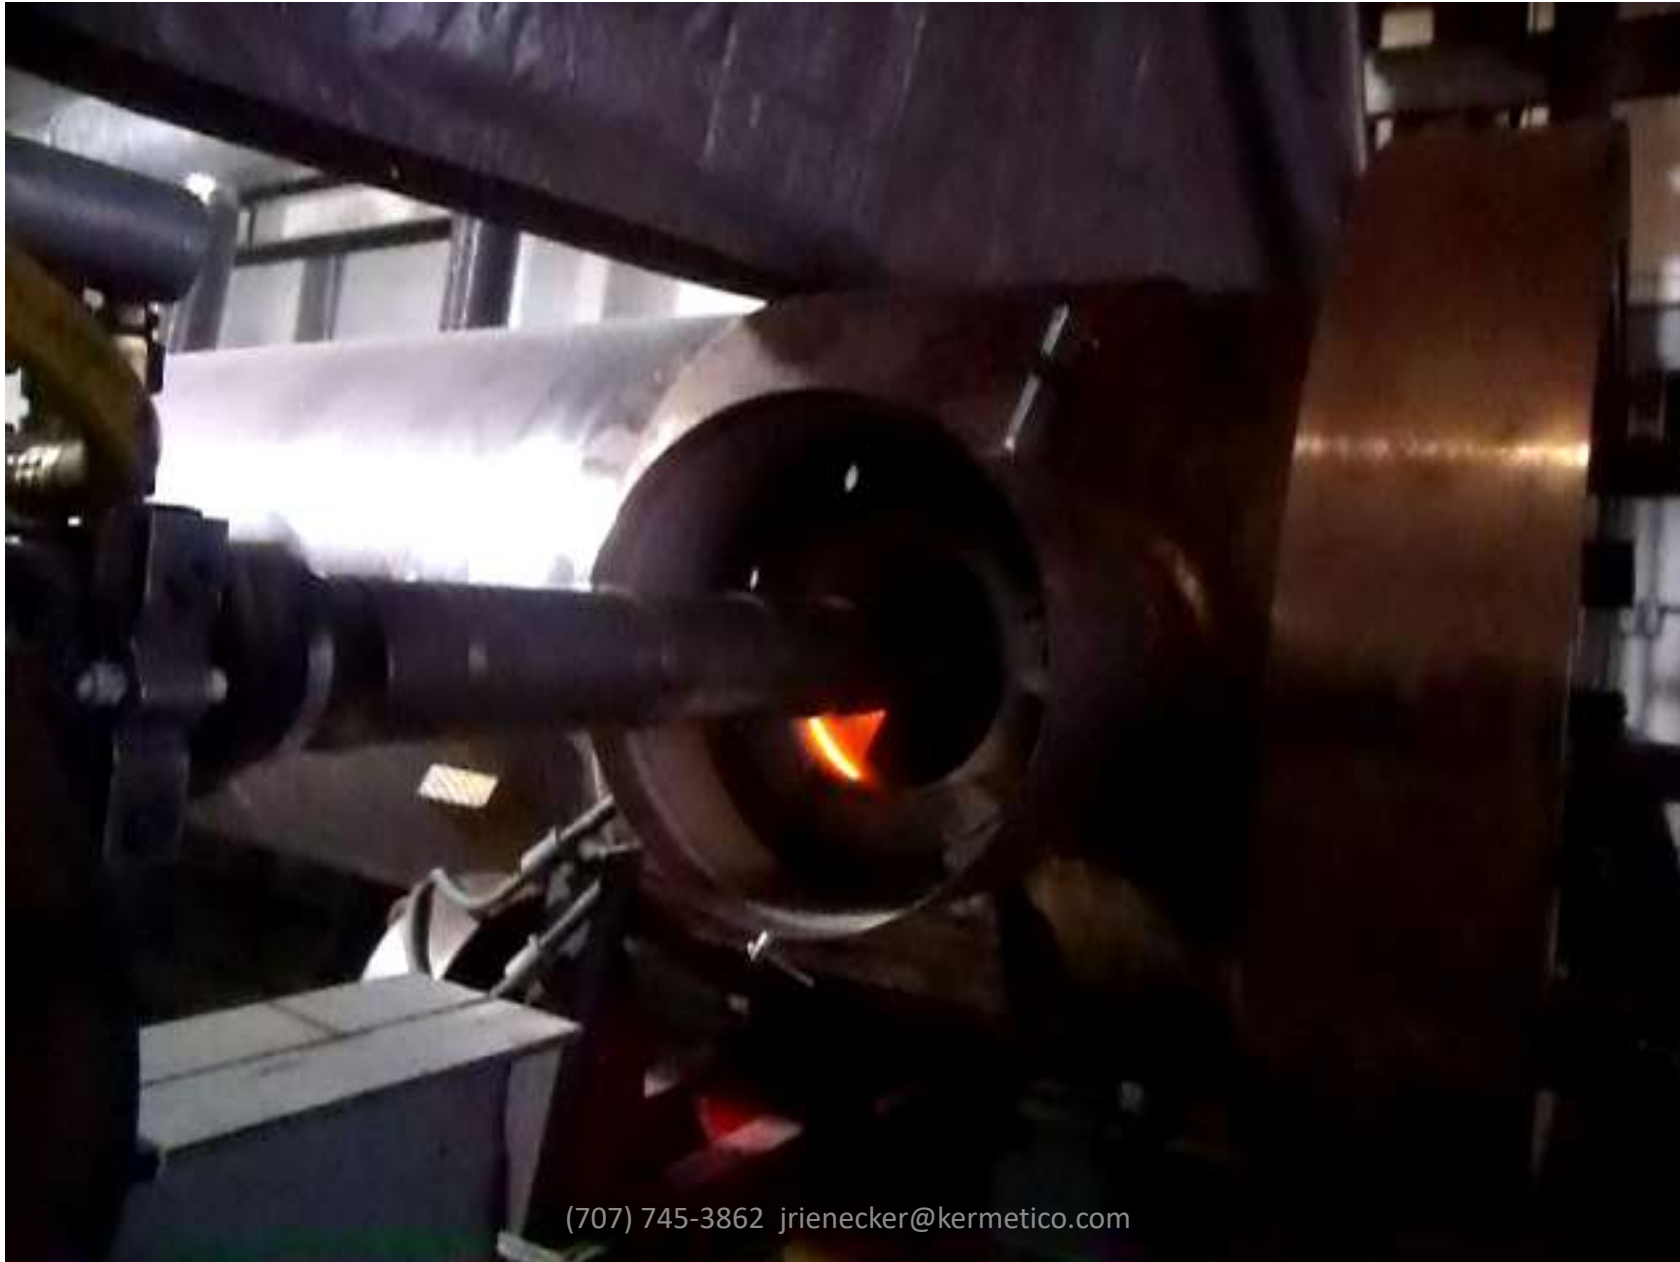
Vessel nozzles are coated with rotating ID guns

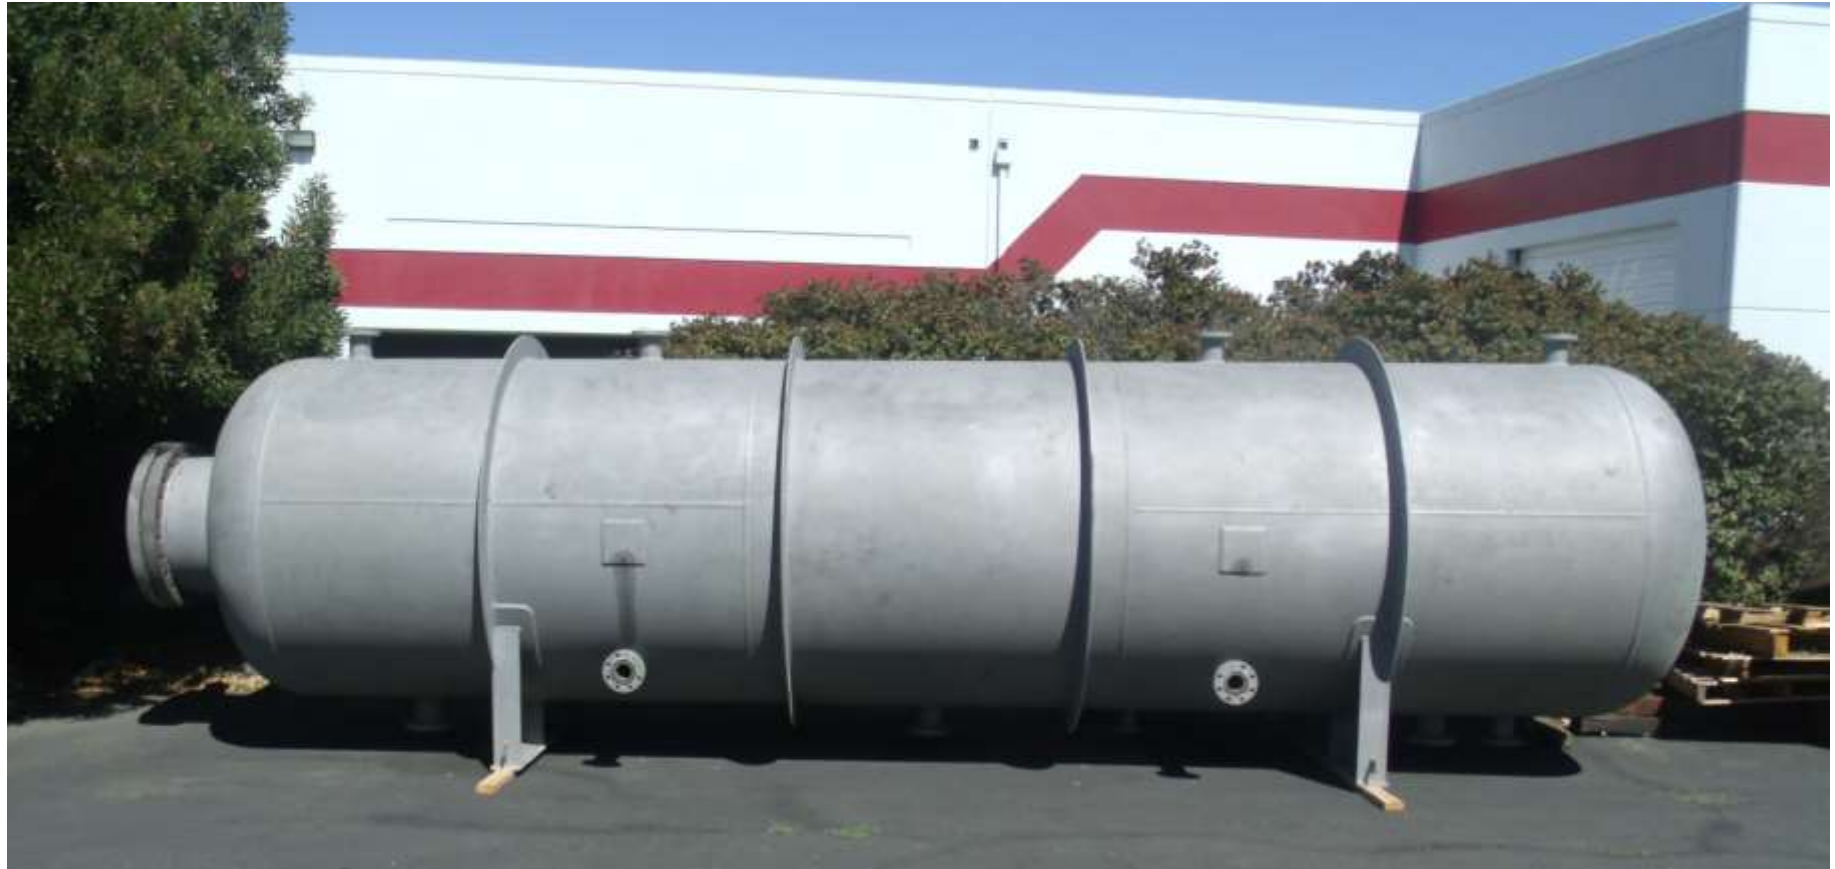
We protect internal surfaces of pressure vessels from sulfur-induced corrosion since 2010

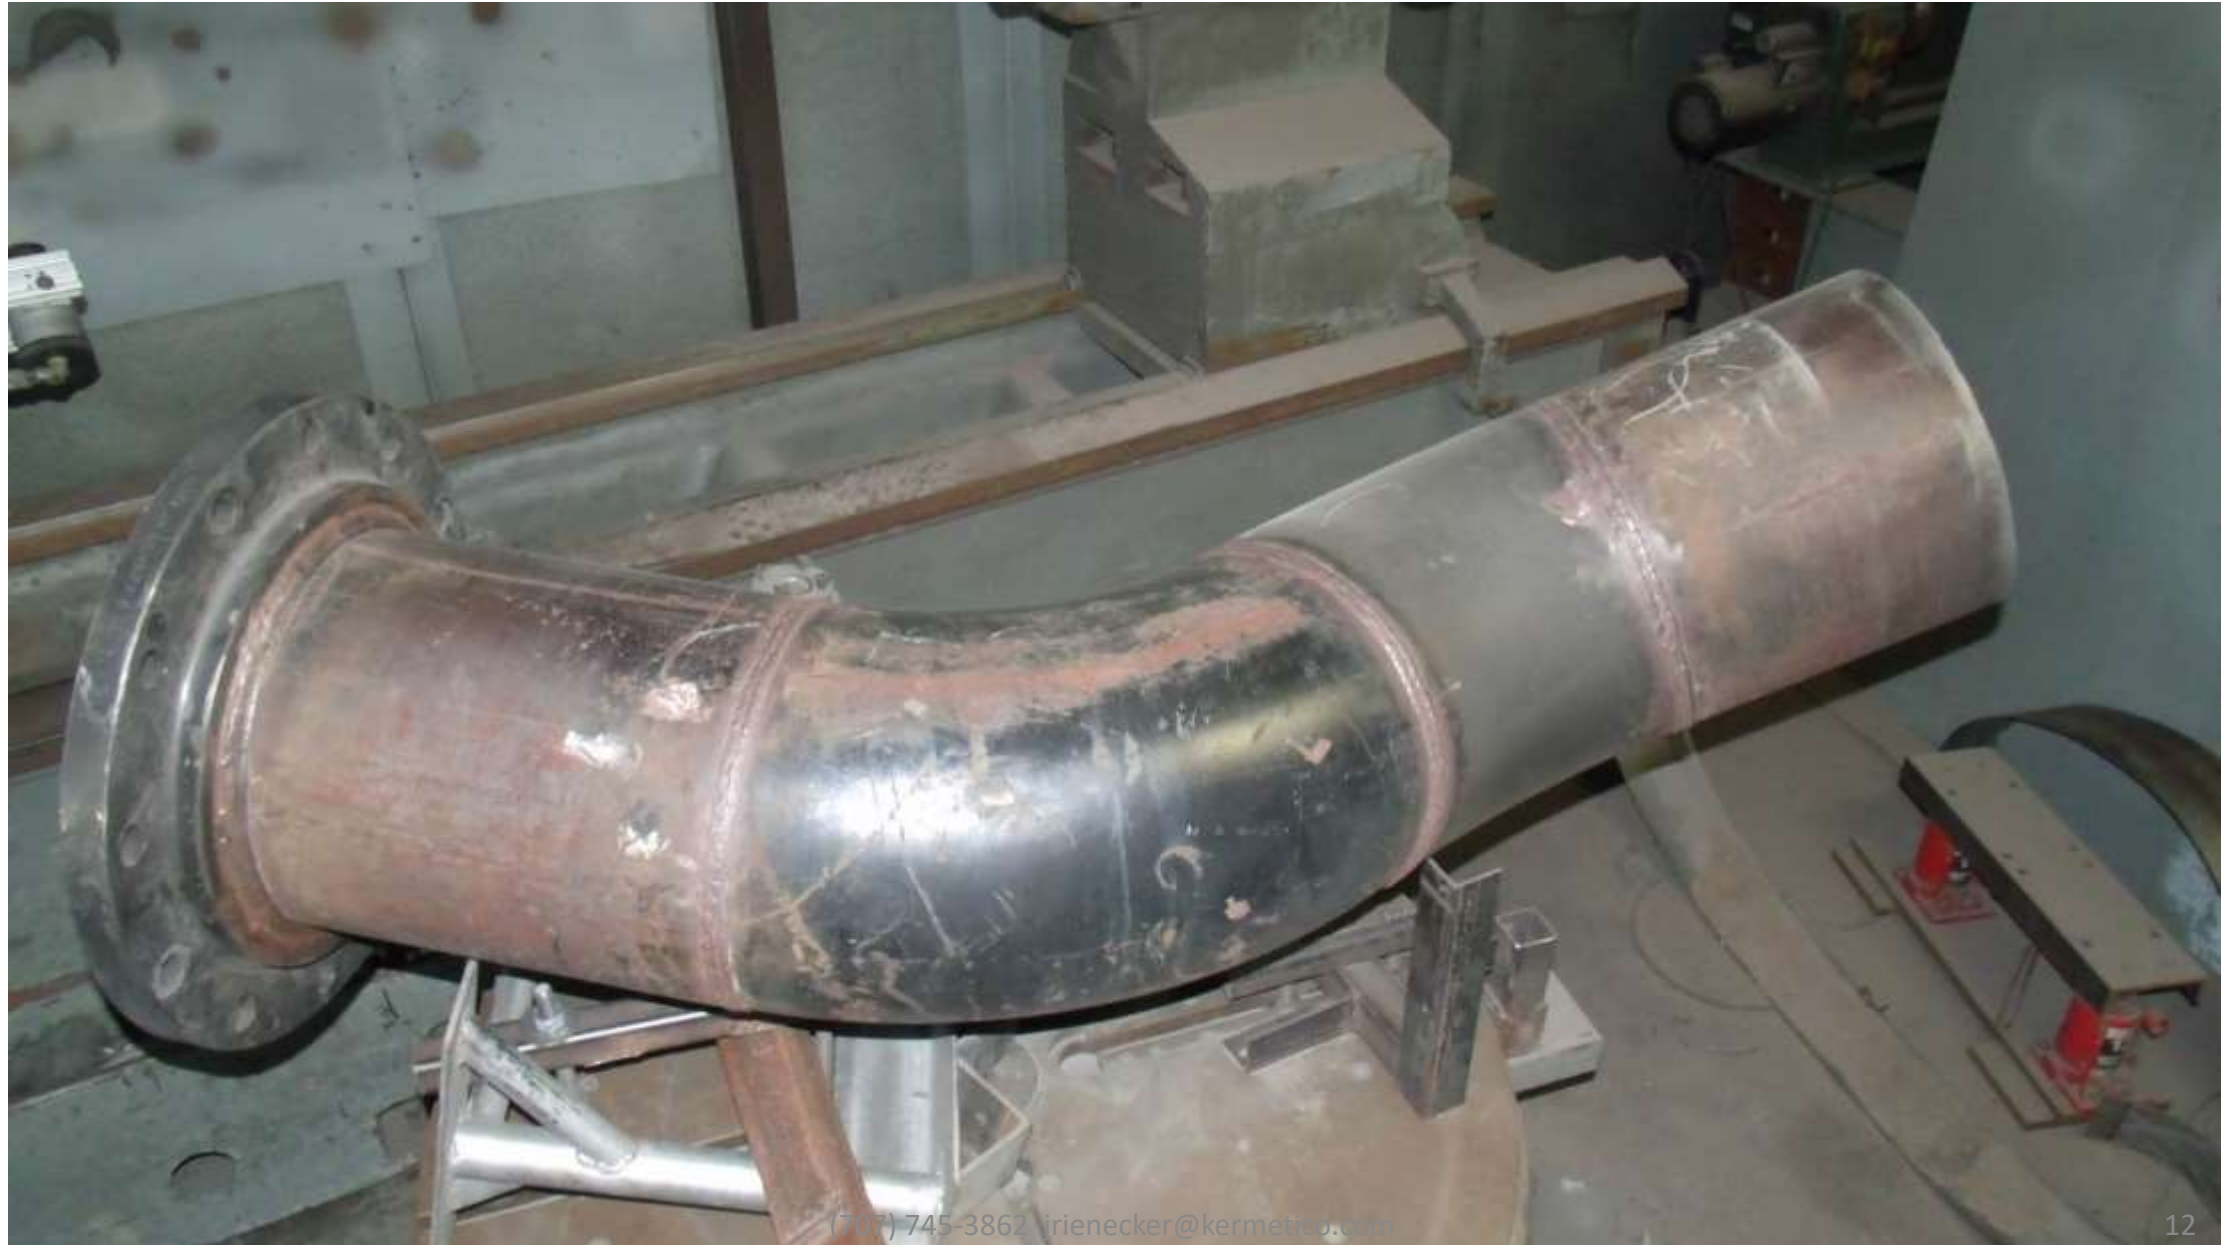
We have a versatile ID coating capability

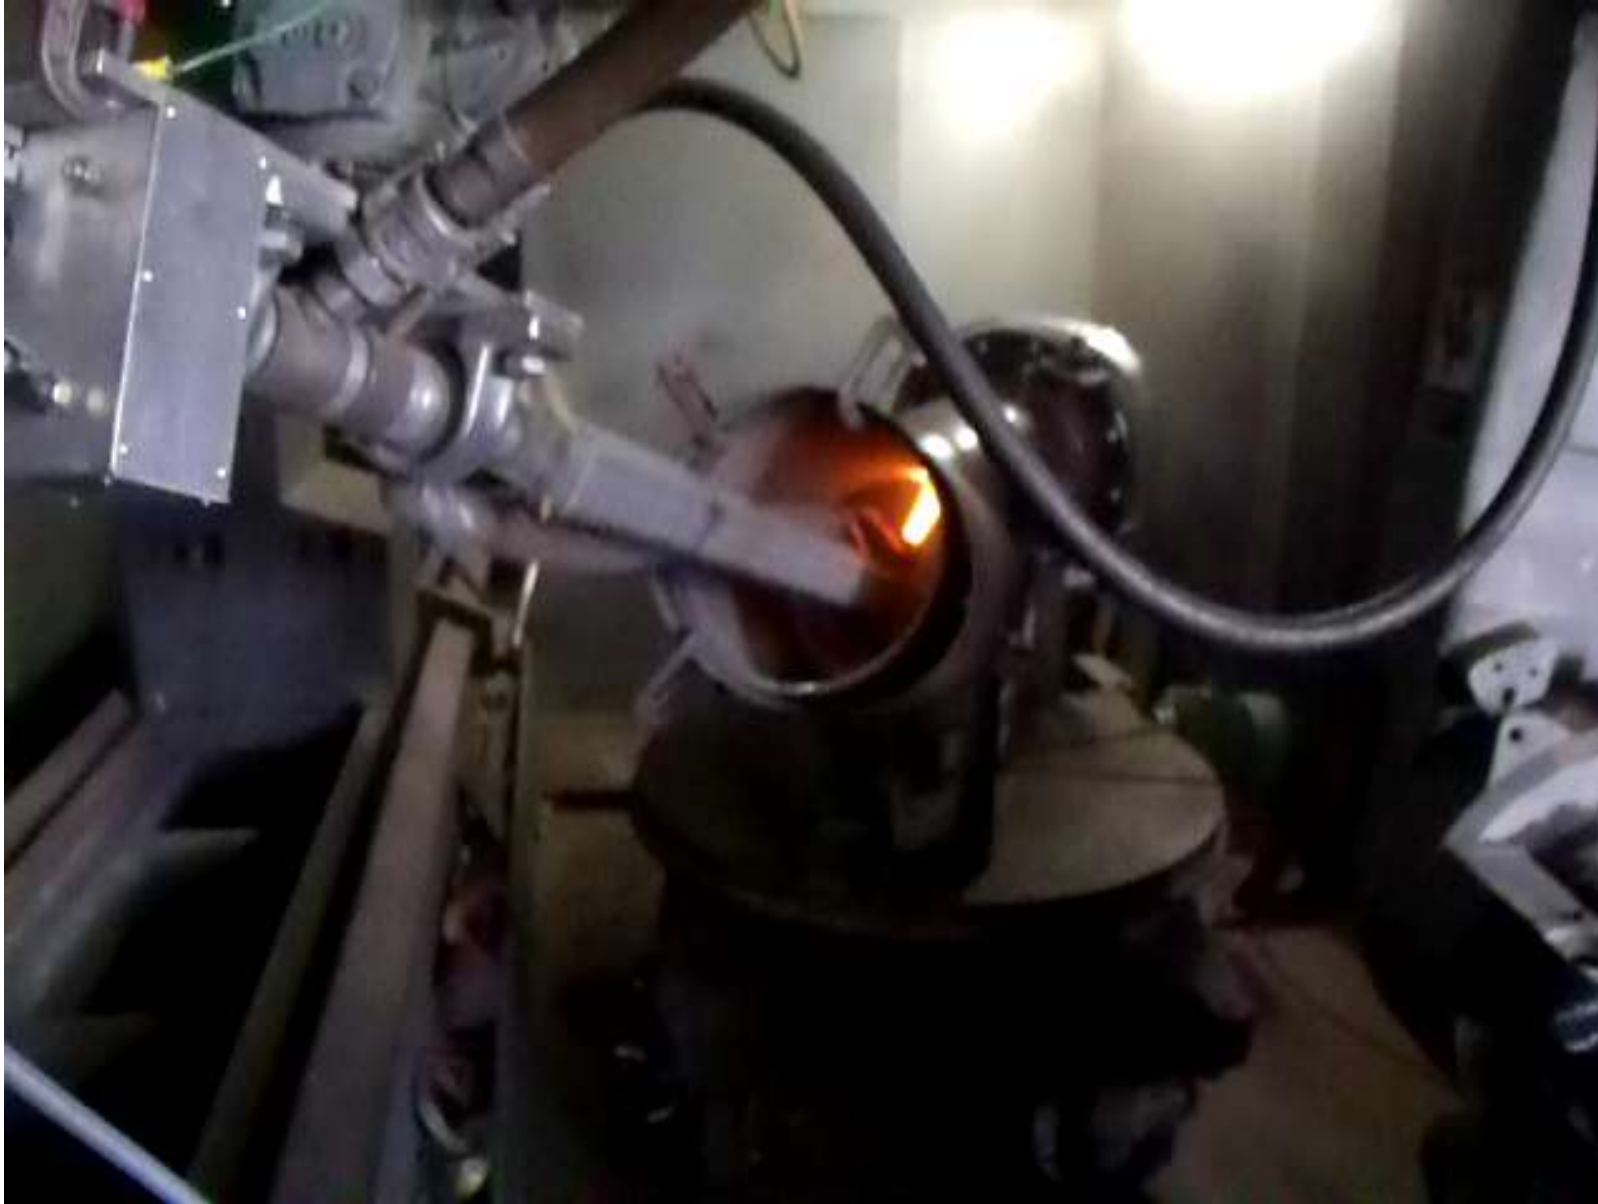
AK5 Rotating HVAF Gun

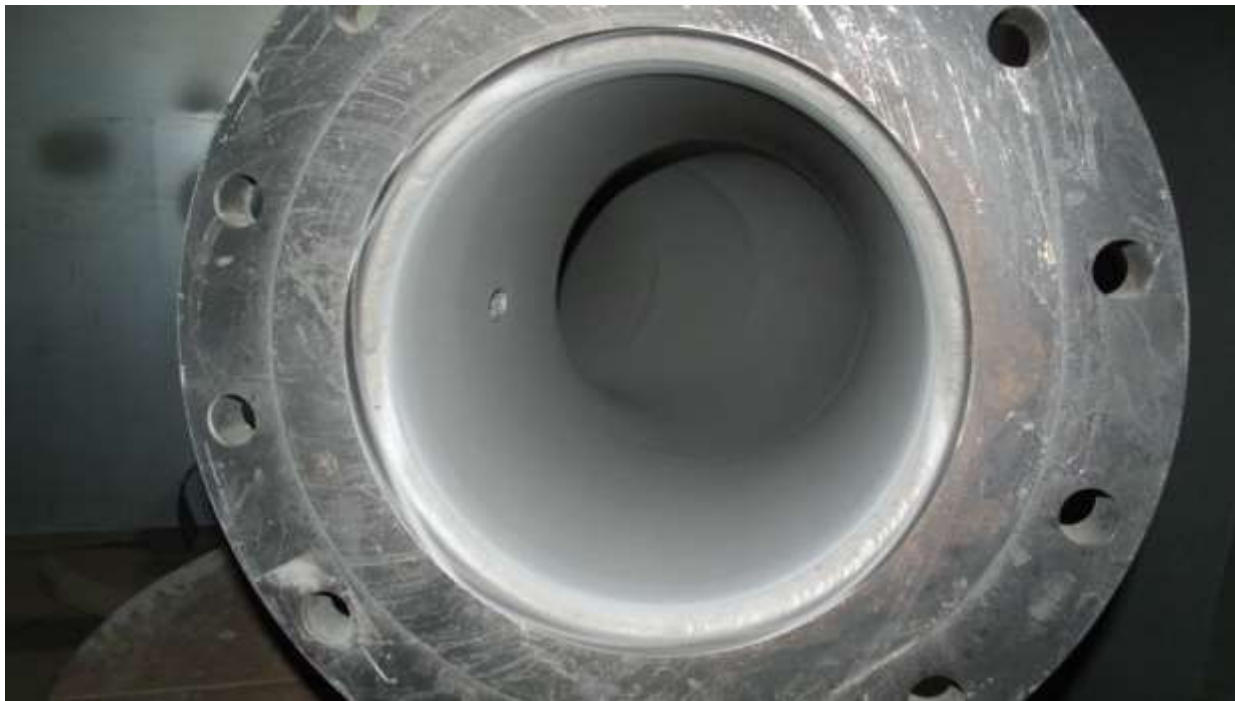
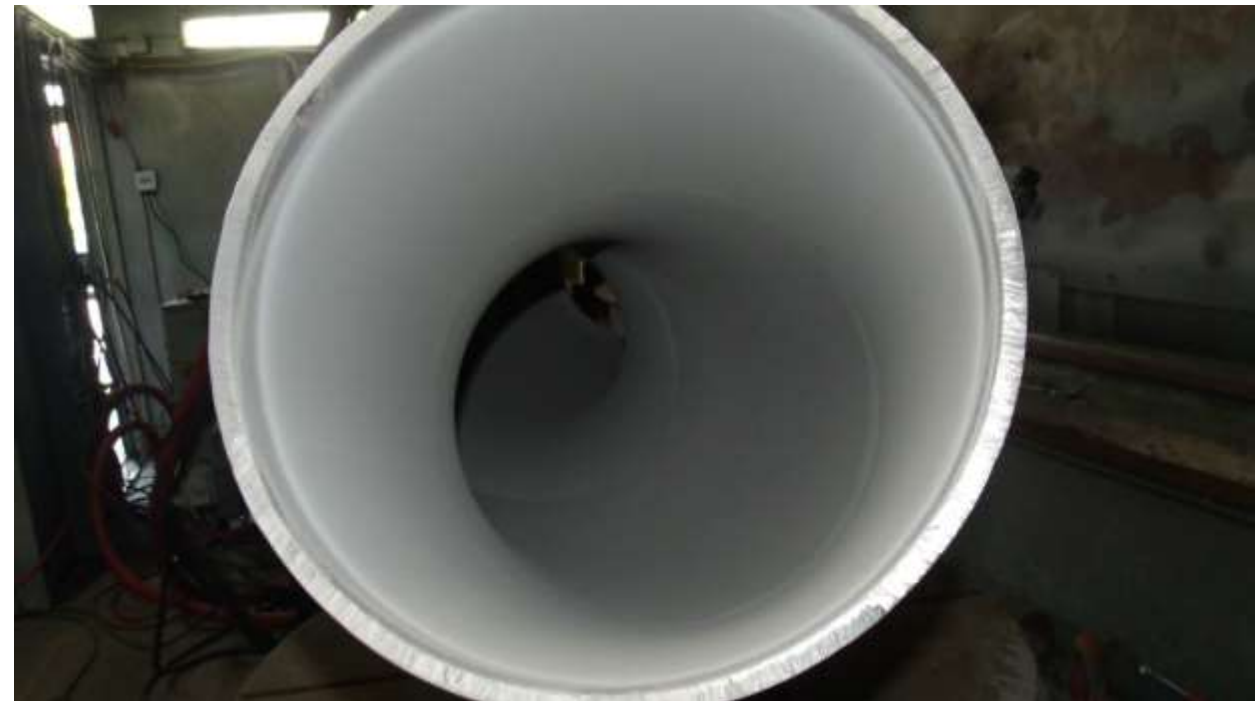
Tungsten Carbide coating from both ends

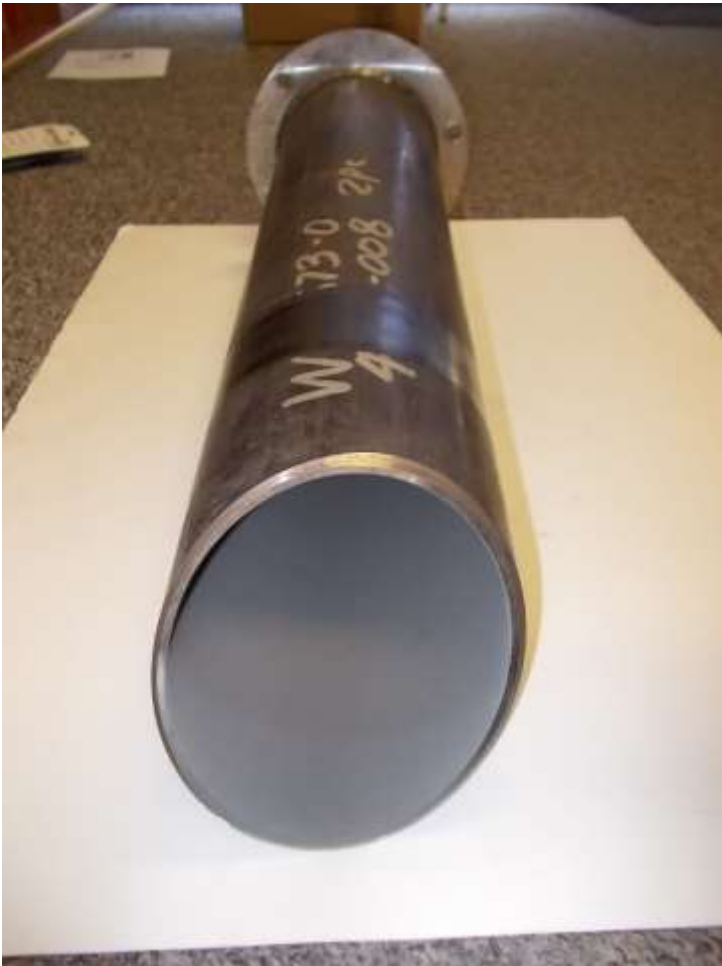
We also do “simple” ID Coatings

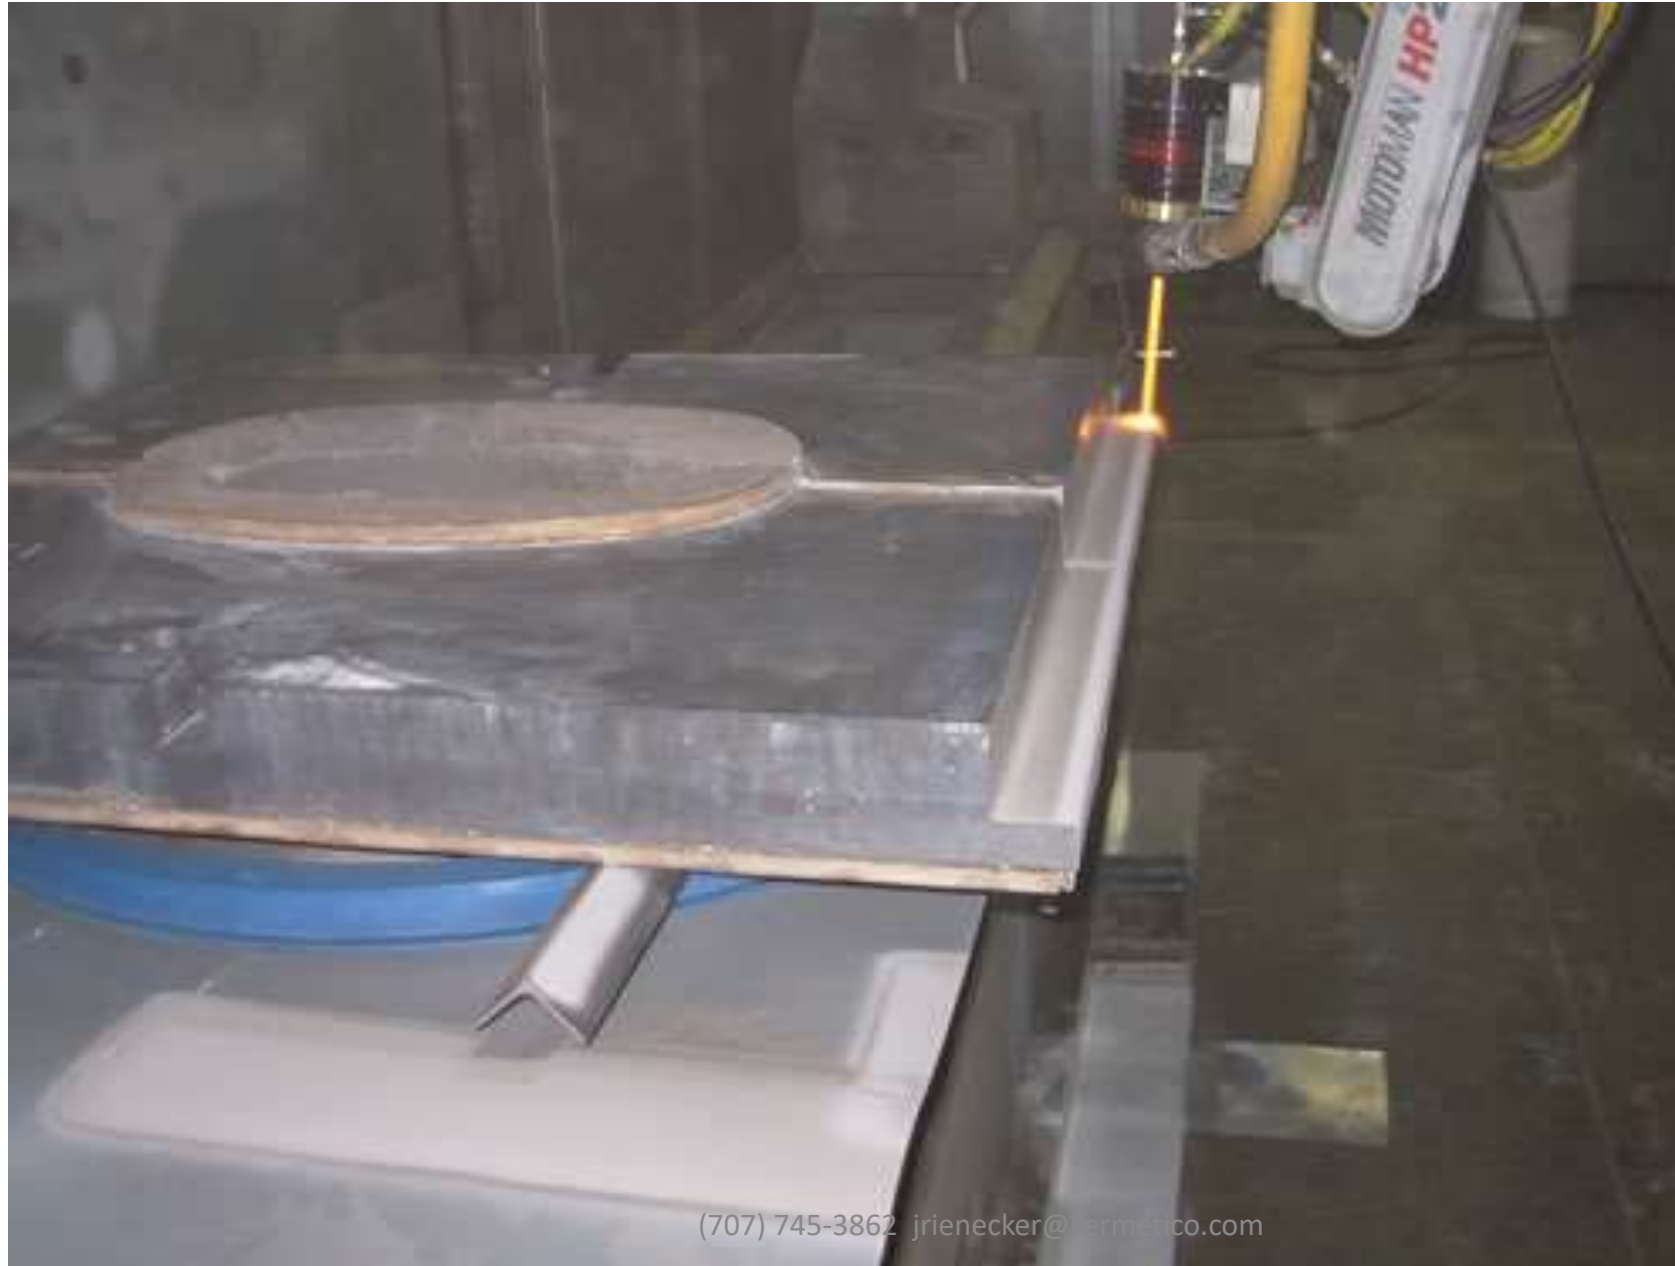
Tungsten Carbide on Part 2 of a Slide Gate Orifice

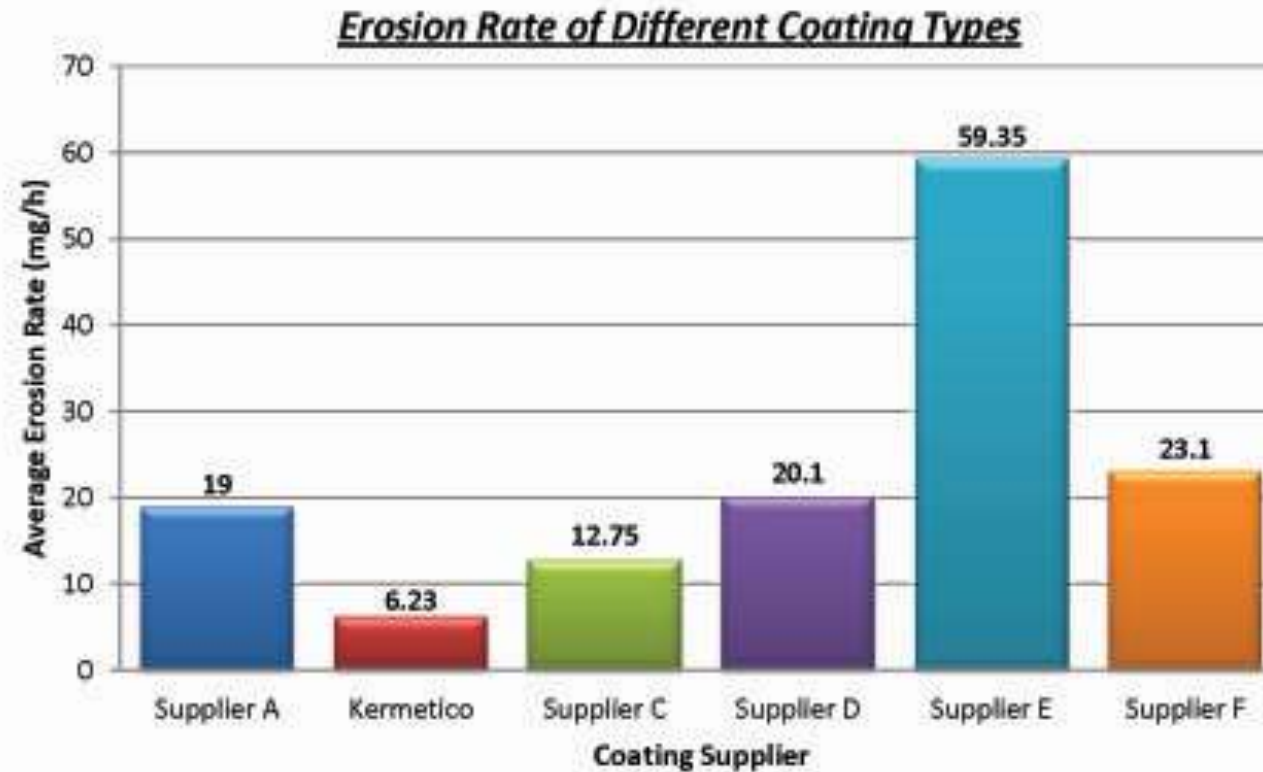
FIGURE 5 - EROSION RATE OF DIFFERENT SUPPLIER COATINGS

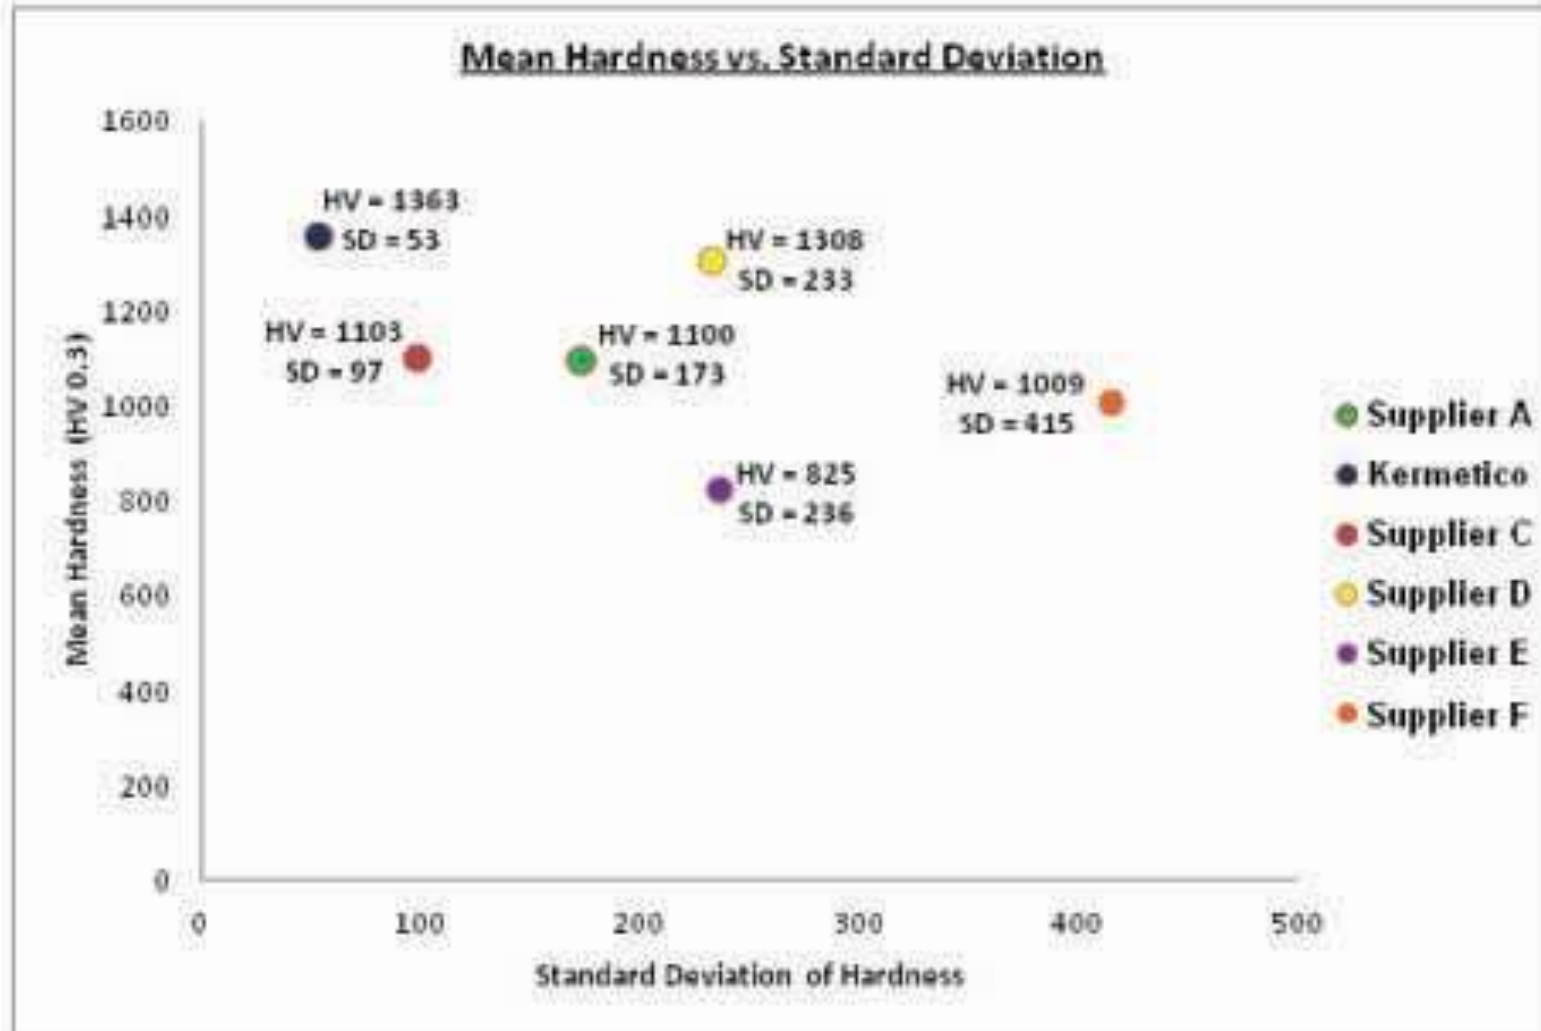
FIGURE 3 - MEAN COATING HARDNESS VALUES AND STANDAD DEVIATION
